Developing Hantavirus Mitigation Procedures for Cultural Resources

During the summer of 1996, an interdisciplinary team of National Park Service (NPS) employees developed Hantavirus mitigation procedures as an integral element of a preservation project to stabilize and partially restore a modest, three-room frame cabin at Agate Fossil Beds National Monument in northwestern Nebraska. The Harold J. Cook Homestead Cabin, or "Bone Cabin" as it is also known, is nationally significant for its association with early 20th century paleontological investigations of fossil deposits in the Niobrara River Valley. The mitigation efforts affected all aspects of the work, from the decontamination, removal and storage of architectural and artifact samples, to structural stabilization and exterior restoration. The preservation treatment represented a synthesis of traditional preservation and conservation procedures, historic accuracy, and health and safety concerns.

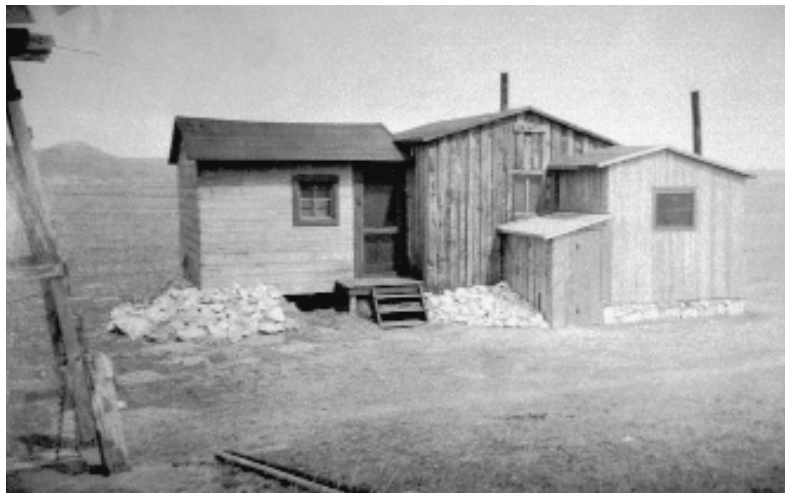
Bone Cabin c. 1912-1914. Bedroom addition is on the left, main cabin at the center, and summer kitchen with attached wood shed on the right. Photo courtesy Agate Fossil Beds National Monument Collection.

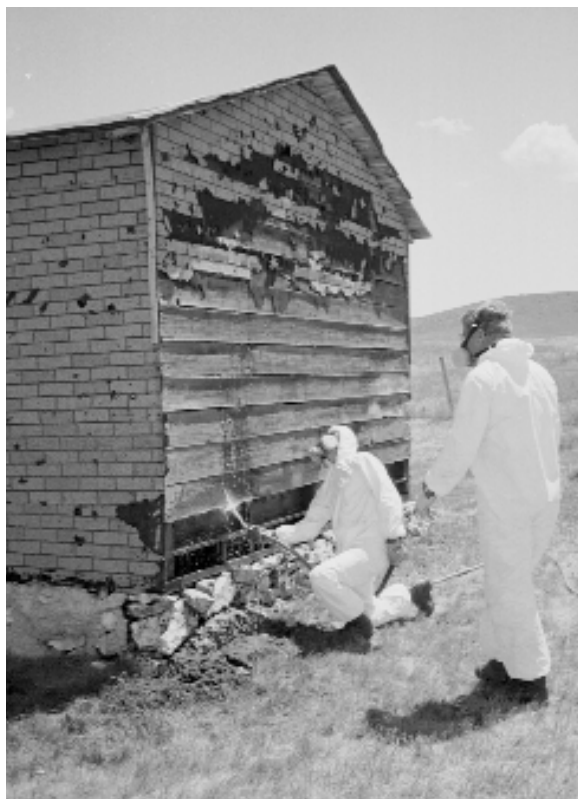
Spraying down the exterior wall in the mitigation effort.

Following selective material sample removals, the team sprayed down all wall, ceiling and floor surfaces, sprayed in the crawl space, and washed out wall cavities of the west room. A mixing container with a control dial was filled with liquid Clorox bleach and attached to the end of a garden hose equipped with an adjustable nozzle. The nesting material and debris were washed out of the building, collected with shovels, and placed in trash bags. The bags were sealed with duct tape and disposed of in a local and state approved refuse landfill. The team disinfected themselves after each phase of selective demolition work by spraying themselves down with the bleach-to-water solution prior to removing their protective suits and masks.

The wallboards created an interesting dilemma: because the tongue and groove boards were installed by Harold Cook as a finish material, the decision was made to retain the material while disinfecting the wall cavities, and discourage future nesting. The solution was to wash out the cavities from the exterior. The condition of the original exterior shiplap siding was too poor to salvage, so select boards were removed in order to access the stud wall cavities. The same garden hose with a bleach-to-water filled container was used to flush out the cavities.
